Report No. 9
CIA/PIR 75035

DATE Sept. 1966

CIA IMAGERY ANALYSIS DIVISION

This report summarizes significant items of photo intelligence relating to the North Vietnamese railroad system which has been developed from available photography during the period indicated on the cover.

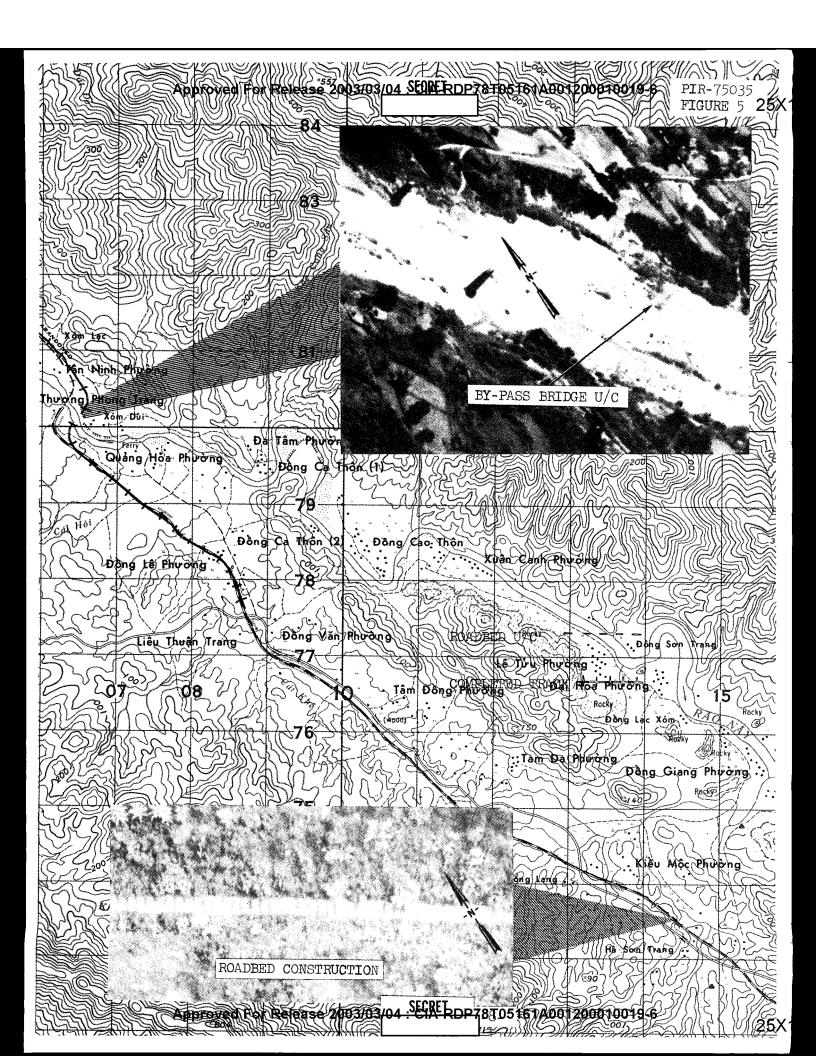
ITEM OF INTEREST NO. 1: Hanoi/Dong Hoi Line

The North Vietnamese continue to reconstruct the Hanoi/Dong Hoi Line southeastward toward Dong Hoi. Construction continues on the by-pass bridge over the Rao Nay (River) at UTM XE 062802 and track now extends beyond this river crossing for 2 nm, ending at UTM XE 086777. Intermittent areas of roadbed construction extend an additional 4 nm to the southeast, ending at UTM XE 145733 (Figure 5).

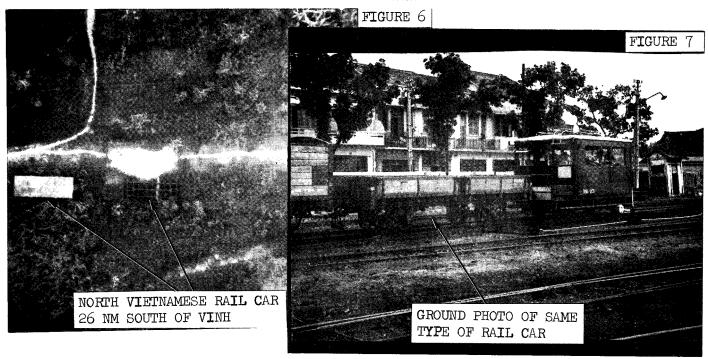
FIGURE 8

Earlier structural analysis (CIA/PIR 65108) of the temporary wood deckbeam bridges built by the North Vietnamese on the Vinh/Dong Hoi Segment established that the safe load limit on this type of bridge was approximately 7-10 tons. Although it is quite probable that the North Vietnamese are exceeding the safe load limit of their bridges, it is interesting to note that if a series of 3 or more coupled flat cars of this type were rolled across one of the wood deck-beam bridges, the maximum weight on the longest span of this bridge would be 15 tons if the flat cars were unloaded, and 42.5 tons if the cars were filled to average capacity.
